# Manhole Inspection Summary

Manhole # S45I2\_003MH

Insp Date: **11/12/08 2:30 PM**

**Location** Address: **Fairhaven Ave.(Near 1500 Elmtree St.)** Cross Street: **Filbert-Elmtree**

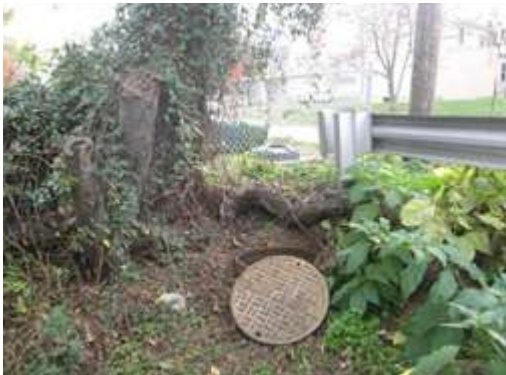
Location View

Near 1500 Elmtree St.

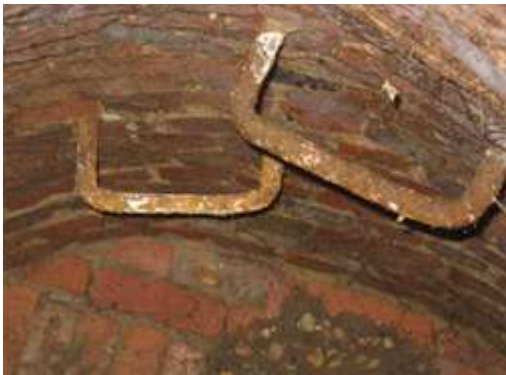
Steps

**Steps** Count: **2** Missing: **0** ☒ **Corroded**

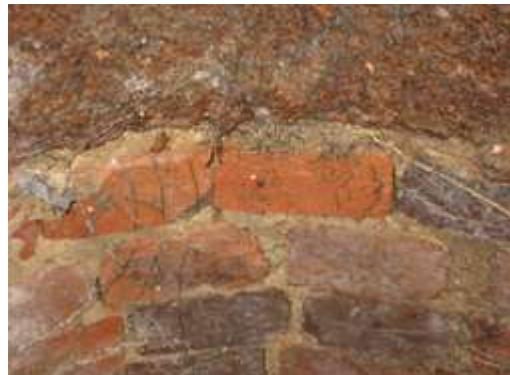
Defect 2

**Chimney / Frame Adjustment** ☒ Exists Material: **Brick** ☐ Parged Height: **4** (in.)  
Condition: ☐ Sound ☒ **Cracked** ☐ Root Intrusion ☐ Loose Brick ☐ Deteriorated  
Infiltration: ☐ None ☒ **Joint** ☒ **Cracks** ☐ Mortar ☐ Roots ☐ Wall

Cracks and infiltration

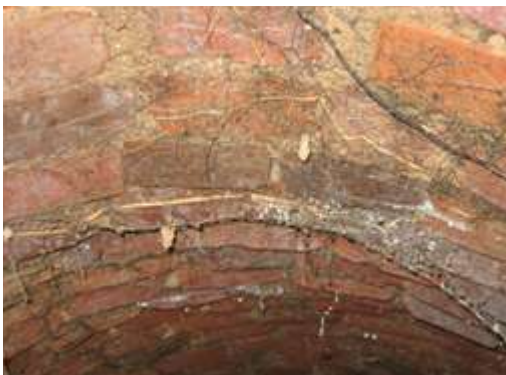
Defect 1

**Corbel** Material: **Brick** ☐ Parged Type: **Concentric/Eccentric**  
Condition: ☐ Sound ☐ Cracked ☒ **Root Intrusion** ☐ Loose Brick ☐ Deteriorated  
Infiltration: ☐ None ☐ Joint ☒ **Cracks** ☐ Mortar ☒ **Roots** ☒ **Wall**

**Barrel** Material: **Brick** ☐ Parged  
Shape: **Circular** Diameter: **42** (in.) Length: (in.)  
Condition: ☐ Sound ☐ Cracked ☒ **Root Intrusion** ☐ Loose Brick ☐ Deteriorated  
Infiltration: ☐ None ☐ Joint ☐ Cracks ☐ Mortar ☒ **Roots** ☒ **Wall**

Root intrusion

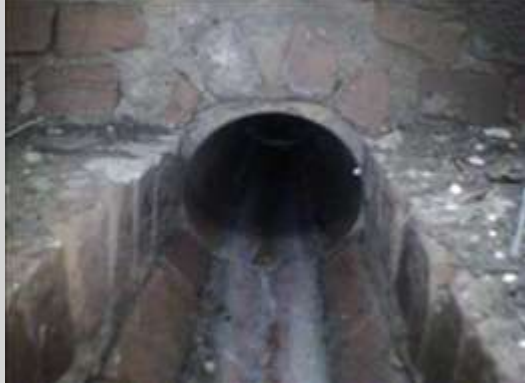
12 O'Clock Outflow

8 in. Circular Gravity Sewer  
Pipe Out @ 12 O'Clock

Pipe Height: **8.4** (in.) Rod and Bar (Angled)  
Pipe Material: **Clay** ☐ Pipe Lined  
Invert Depth: **7.00** (ft.) Flow Characteristics: **Fast**  
Deposits: ☒ None ☐ Mud ☐ Sludge ☐ Debris ☐ Grease  
Silt Depth: (in.) Deposits Extent:  
Infiltration: **None** Pipe Seal Cond: **Sound**

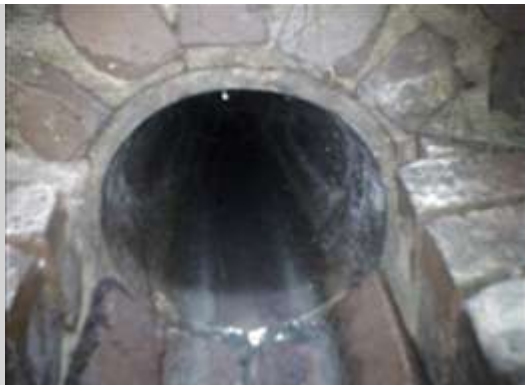
6 O'Clock Inflow

8 in. Circular Gravity Sewer  
Pipe In @ 6 O'Clock

Pipe Height: **8.4** (in.) Rod and Bar (Angled)  
Pipe Material: **Clay** ☐ Pipe Lined  
Invert Depth: **6.24** (ft.) Flow Characteristics: **Fast**  
Deposits: ☒ None ☐ Mud ☐ Sludge ☐ Debris ☐ Grease  
Silt Depth: (in.) Deposits Extent:  
Infiltration: **None** Pipe Seal Cond: **Sound**
